# Manhole Inspection Summary

Manhole # S35CC\_002MH

**Inspection** ☐ Is Incomplete Rating: **4) Poor**

**Location** Address: **EAGER ST**

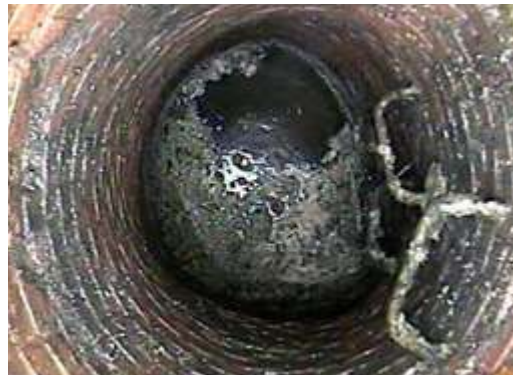
Defect 1

**Steps** Count: **6** Missing: **0** ☒ **Corroded**

STEPS CORRODED

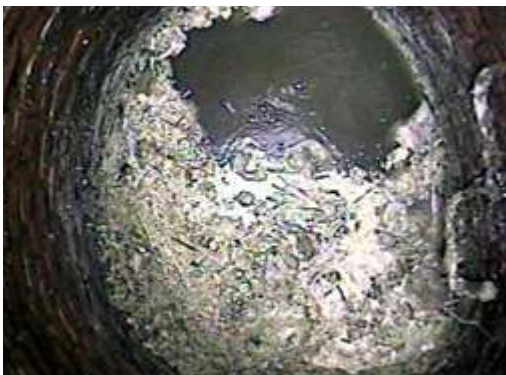
Defect 2

**Active Surge - 3 Attempts - Surcharged Conditions  
Verified through CCTV - Need Specialty Cleaning**

Comments **SURCHARGE UP TO 8FT ON STEPS**

Condition: ☐ Sound ☐ Cracked ☐ Root Intrusion ☐ Deteriorated ☐ Leaks ☒ **Debris**

**Surcharge** ☒ **Evidence Of Surcharge** Depth: **8** (ft.) ☒ **Active Surcharge Present**

EVIDENCE OF SURCHARGE/ DEBRIS

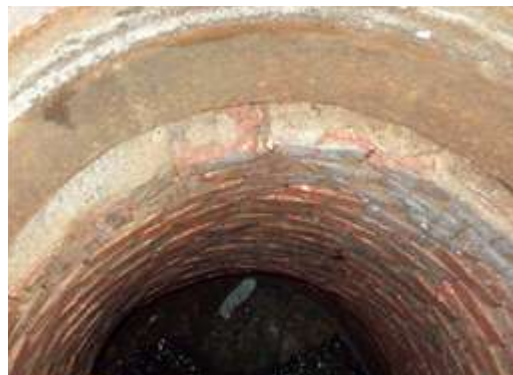
Defect 3

**Frame** Offset: **3** (in.) Condition: ☒ Sound ☐ Cracked ☐ Leaks

OFF SET FRAME

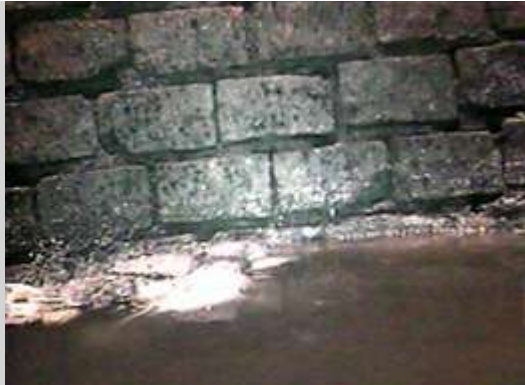
12 O'Clock Outflow

8 in. Circular Gravity Sewer  
Pipe Out @ 12 O'Clock

Pipe Material: **Clay** ☐ Pipe Lined

Invert Depth: **10.70** (ft.) Flow Characteristics: **None**

Deposits: ☒ None ☐ Mud ☐ Sludge ☐ Debris ☐ Grease

Infiltration: **None** Pipe Seal Cond: **Sound**

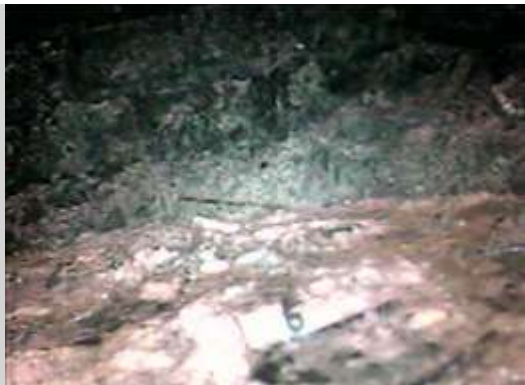
5 O'Clock Inflow

8 in. Circular Gravity Sewer  
Pipe In @ 5 O'Clock

Pipe Material: **Clay** ☐ Pipe Lined

Invert Depth: **10.00** (ft.) Flow Characteristics: **None**

Deposits: ☒ None ☐ Mud ☐ Sludge ☐ Debris ☐ Grease

Infiltration: **None** Pipe Seal Cond: **Sound**
